International Institute of Ammonia Refrigeration

## Technical Paper #12

# Don't Curse the Purger

### **Abstract**

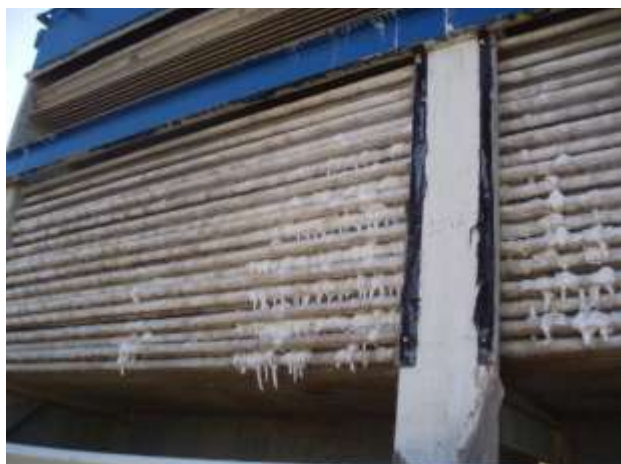
Figure 1. Consequences of poor condenser operation.

Head pressure was a challenge due to scale accumulating on equipment insulating the heat transfer surface. Not only was heat transfer impaired by a thick scale jacket, the velocity of the air passing the coil tubes increased. Faster air speed meant less residency time of air/water interfacing the coil surface, which was confirmed through observation that two-thirds of the coil tube was “dry” in appearance. The dry area developed a “beard” of scale stubble from the 4 o’clock position down and around to the 8 o’clock position of each horizontal pass of the coil. With fans operating at full speed, two-thirds of each tube pass operated “dry” because of the speed of the fan air transiting from below. Consequently, one-third of the heat transfer surface did not receive adequate contact with the air/water that should have enveloped the entire tube. The water treatment effort was not sufficient: regulations forced a change of treatment material to polymers and the water conservation effort thwarted blow down. It was an ugly period of trial and error. All these issues resulted in higher condensing pressure.

The problem compounded as weeks went by. The scale beard became thicker and the distance between tubes decreased. The speed of the air passing through the coil bundle increased, while the tubes ran “dryer” and the head pressure ran higher. There were times when it appeared there was 25 psi or more of excess pressure due to non-condensable gases. Manual purging was the only approach at that time.

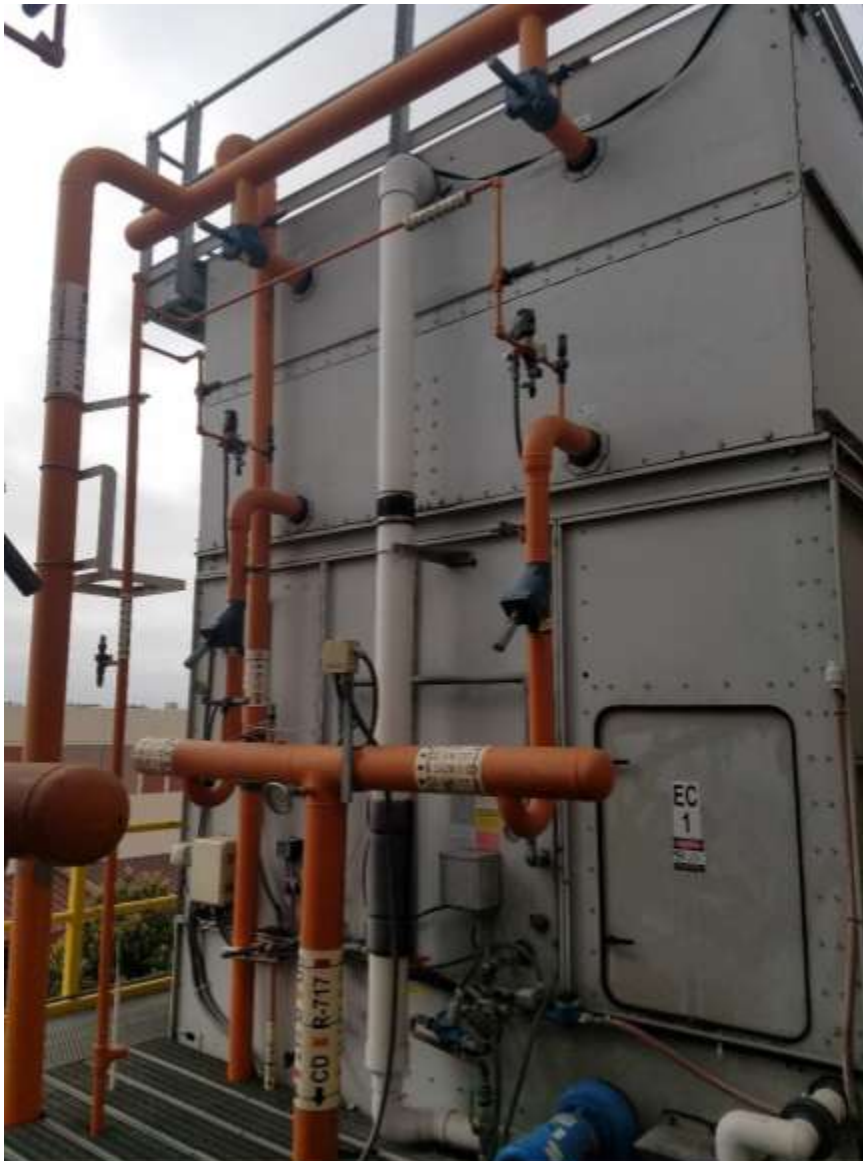
The facility where the cause of the trouble was discovered has two equally sized condensers which receive proper water treatment and care. There is no scale on the surfaces. The two condensers discharge into their own horizontal collection header, downstream of the P-traps of each coil (Figure 3). Each of the four condenser coils has a solenoid-controlled purge point. Again, the installation was built as designed by a competent and reputable contractor. The discharge from each 6" horizontal collecting drain header dropped through the ceiling into the engine room. The flow from the two condensers comes together and enters the side of a thermosiphon pilot receiver for the oil cooling system of the four compressors. The condenser fans and pumps work in tandem. Pumps come on together first, then fans start as required for floating head pressure. The condensers essentially split the load equally. The typical head pressure is 135 psig at light load and 150 psig at full load.

Figure 3. The “north” condenser (EC1) at the facility. The “south” condenser is off-frame to the left and is installed in a mirror fashion to EC1.
